SEMIANNUAL PROGRESS REPORT
DETERMINATION OF THE EMISSIVITY OF MATERIALS
CONTRACT NAS3-4174

Report Period: November 15, 1966, Through May 14, 1967

Technical Management: National Aeronautics and
Space Administration, Lewis Research Center
Space Power Systems Division
J. A. Milko

Pratt & Whitney Aircraft

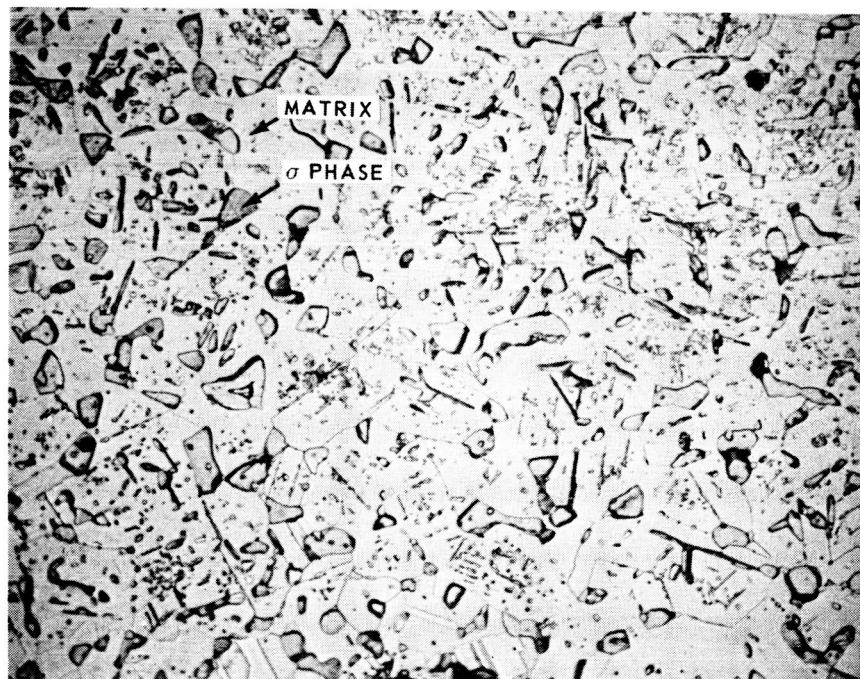
Figure 5 Etchant: 43% Glycerine, 43% HCl, 14% HNO₃
Photomicrographs of AISI-310 Stainless Steel Tube Coated with
Calcium Titanate and Tested for 20,000 Hours at 1350°F

The photomicrographs shown in Figure 5 were etched to reveal the precipitates, but the etchant removed material from the interface between the coating and the substrate, making it appear that separation had occurred. The fact that no separation did occur is evident in the unetched photomicrograph shown in Figure 6.

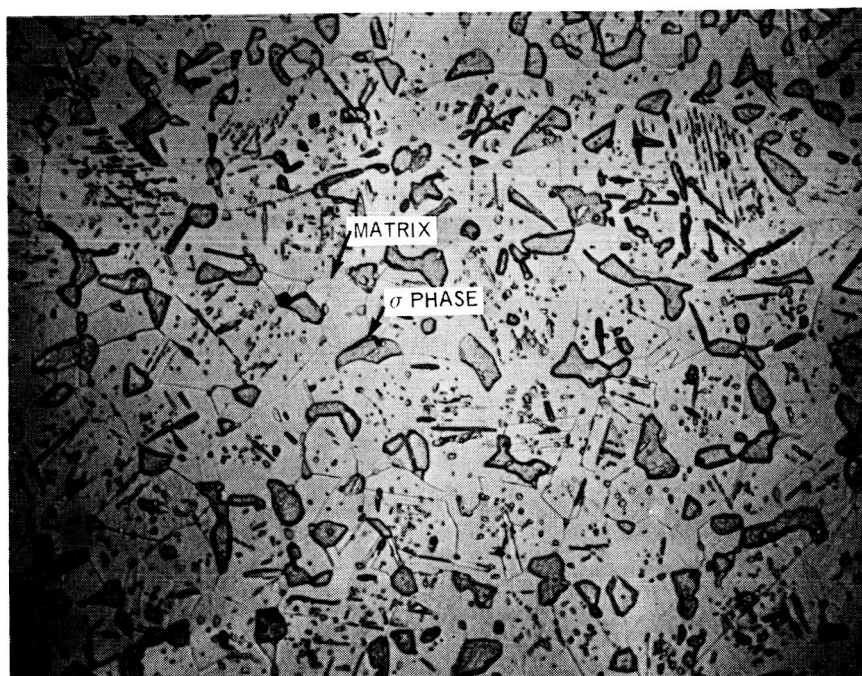
Etchant: 43% Glycerine, 43% HCl, 14% HNO₃
 Figure 13 Photomicrographs of AISI-310 Stainless Steel Tube Coated with
 Iron Titanate and Tested for 20,000 Hours at 1350°F

The endurance-tested coated specimen was sectioned for metallographic analysis. The etched photomicrograph (see Figure 13) shows that the substrate contained precipitates which were identical in appearance to those observed in the calcium-titanate-coated specimen. The slight difference in size and distribution of the precipitates in this substrate from those observed in the calcium titanate-coated substrate is considered to be due to normal variations in the precipitation reaction from section to section. An unetched photomicrograph is shown in Figure 14. As shown, no separation is evident between the coating and the substrate.
